One small plot replicated field trial was conducted during November 2008 to November 2009 to evaluate the efficacy of TERMITIUM® for the prevention of termite penetration through mortar joints over a 3 year period against termites of economic importance in the building industry in Australia. The trial was conducted at Mangrove Mountain in the central coast region of New South Wales Australia. This report contains the experimental methods used and presents the results obtained for the first 12 months of the trial.

The following treatments were evaluated against *Coptotermes acinaciformis*:

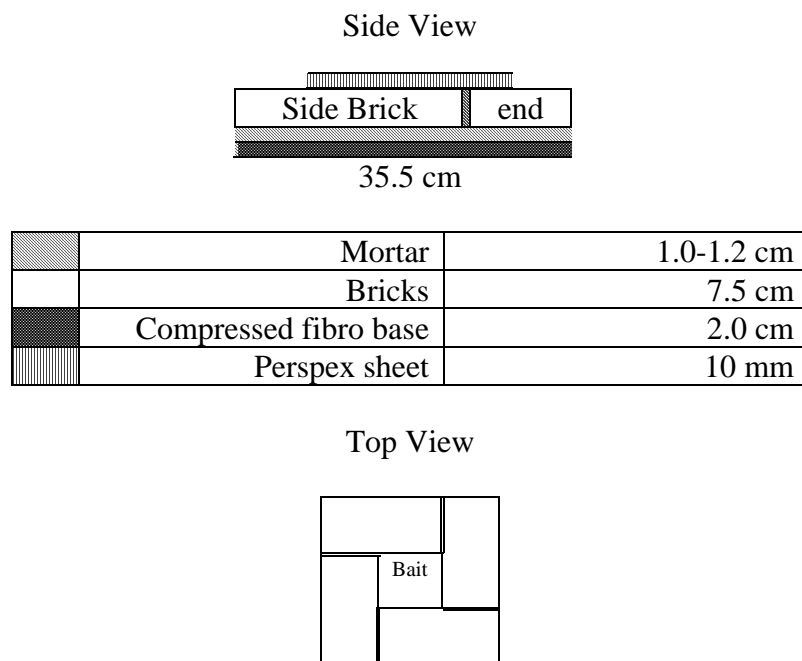
Figure 1:

The treatments were applied by paint brush to 4 bricks and associated mortar joints as shown in figure 1 below:

The bait inside the bricks, mortar, Perspex and compressed fibro structure consisted of a block of radiata pine, a piece of corrugated cardboard and a piece of Styrofoam.

The Perspex sheet on all replicates of both treatment groups was fixed in place using Termite Proof Silicone sealant, grey in colour and Lot# 0005171069 and a use by date of Aug 2009.

The treatments were applied by paint brush to 4 bricks and associated mortar joints for each replicate as shown below:

Mortar	1.0-1.2 cm
	Bricks	7.5 cm
	Compressed fibro base	2.0 cm
	Perspex sheet	10 mm

Each treatment replicate was 35.5 cm long x 35.5 cm wide x approximately 12 cm deep as shown in Figure 1. There was a 20 cm spacing left between each replicate as well as at the ends, therefore, each length of trench was 134 cm long.
